Kinergo Repair Kit For DQ200 (0AM, 0CW)

**DSG/0AM Accumulator Housing
Repair Kit
Part No. 120.MP.80**

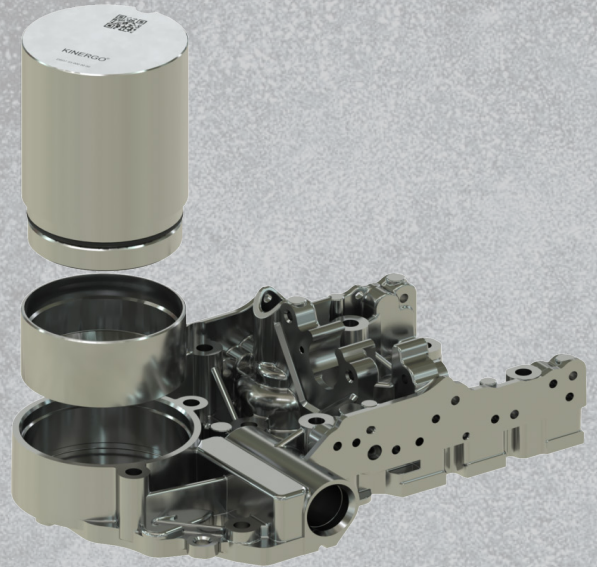
This repair kit allows you to perform the repair of the DSG 7 (0AM, 0CW DQ200) series gearboxes with a “dry clutch” in case of pressure problems. Pressure loss occurs as a result of cracks or structural failure (loss of tightness) in the area where the accumulator is attached to the valve body. Repair with the Kinergo kit does not require replacement of the mechatronics plate. The cup is fastened with standard screws for fastening the plate to the mechatronics body.

The Repair Kit includes:
Hydraulic accumulator – 1 pc.
Cup (adapter) – 1 pc.
O-ring – 2 pcs.

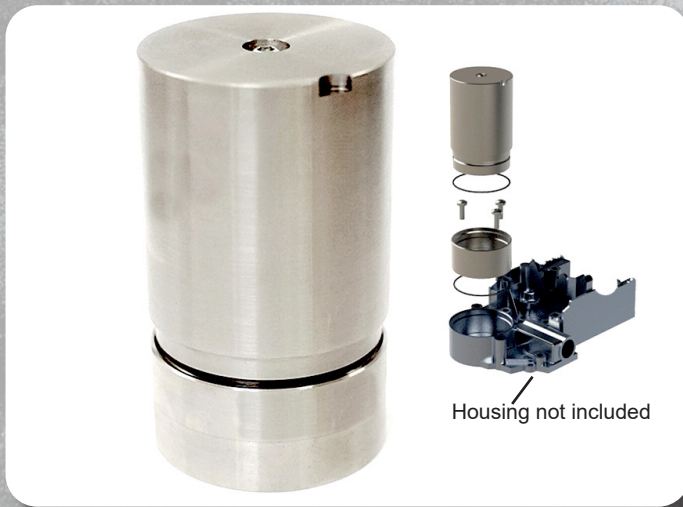
**DSG/0AM Wrench For Accumulator
Housing Repair Kit
Part No. 120.TL.80**

Order Special mounting wrench separately.
